NATIONAL ADVISORY COMMITTEE FOR AERONAUTICS

No. 1626

A STUDY OF CERAMIC COATINGS FOR HIGH-TEMPERATURE PROTECTION OF MOLYBDENUM

By D. G. Moore, L. H. Bolz, and W. N. Harrison

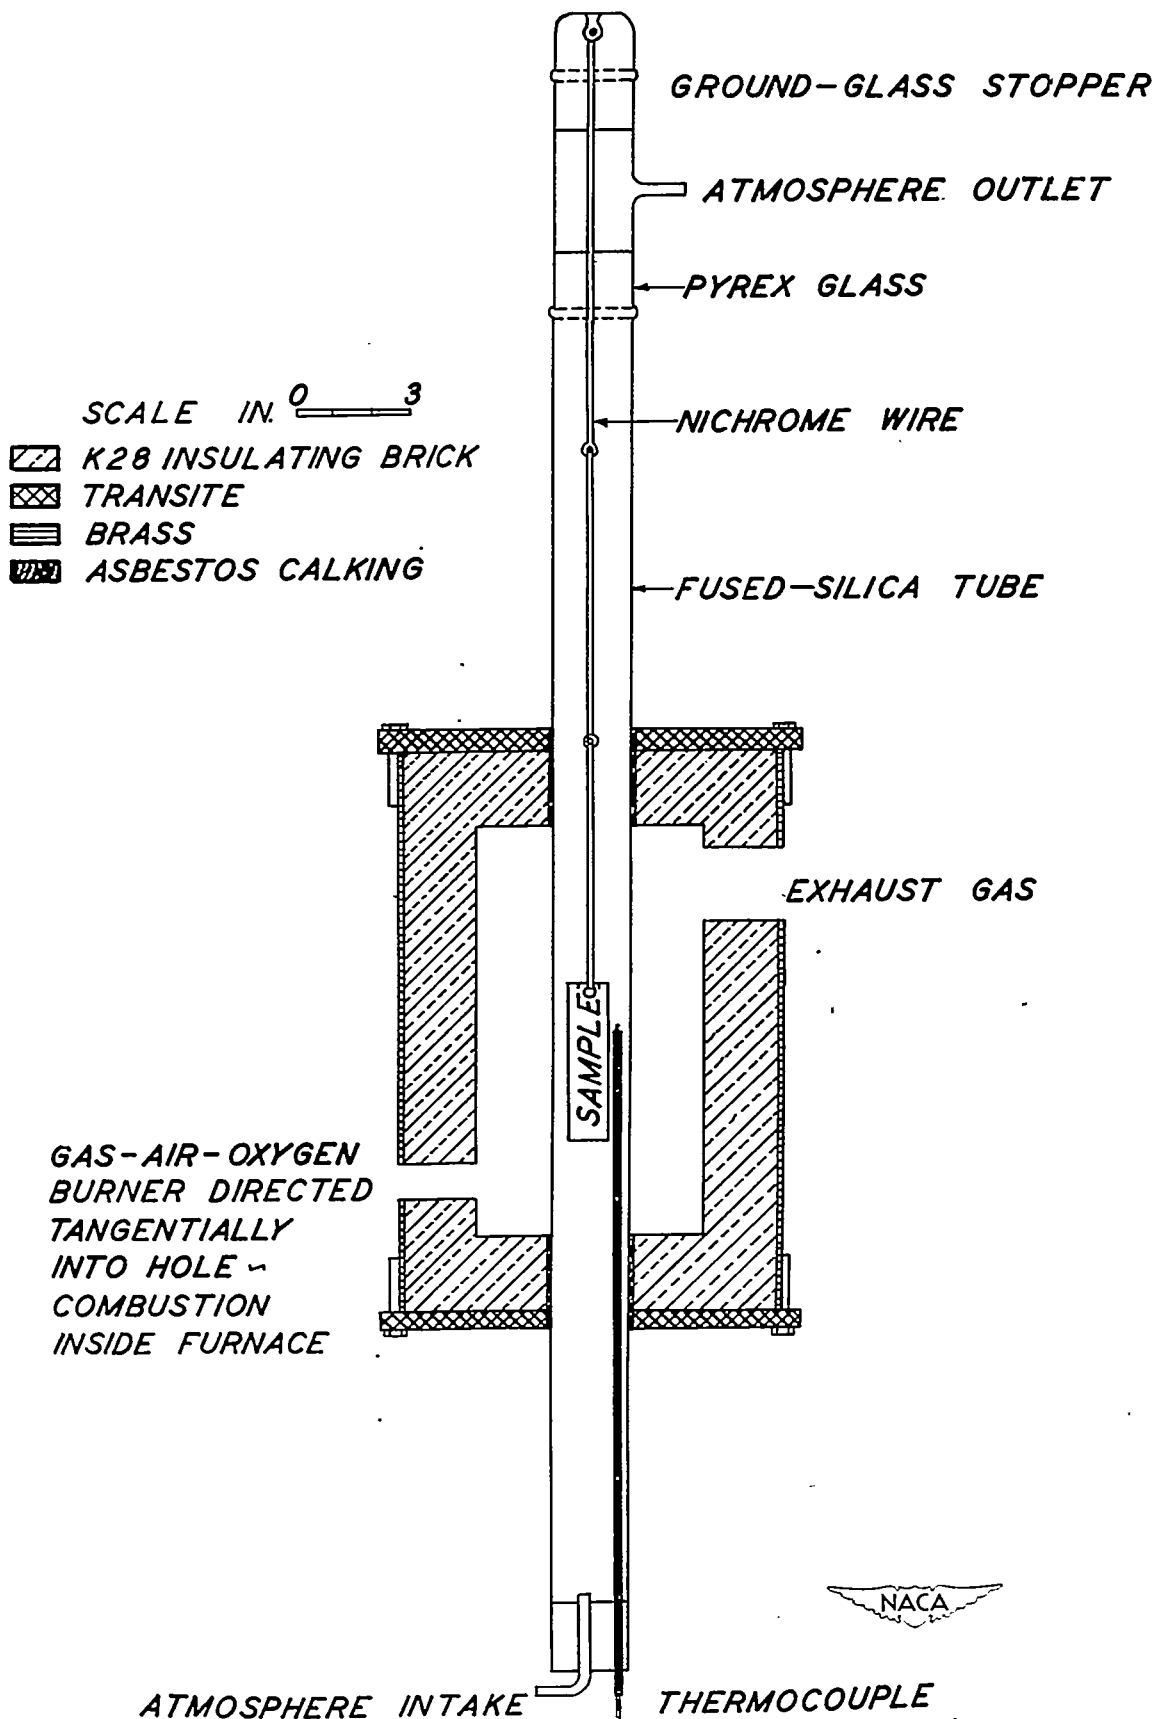
Figure 1.- Schematic diagram of fused-silica tube furnace used for controlled-atmosphere firing of ceramic coatings on molybdenum.

After drying, the test specimens were fired, many of them in a fused-silica tube furnace with controlled atmosphere. A sketch of this gas-fired furnace is shown in figure 1. Temperatures up to 2550° F inside the tube could be attained by supplementing the air supply with a slight amount of oxygen. Without extra oxygen, temperatures of 2400° F could be reached. The temperature was controlled during firing to $\pm 20^\circ$ F by manual adjustment of the gas valve. Most of the specimens used in this study were fired at 2150° F by introducing into the hot furnace, heating for about 5 minutes, removing from the furnace, and cooling in air.

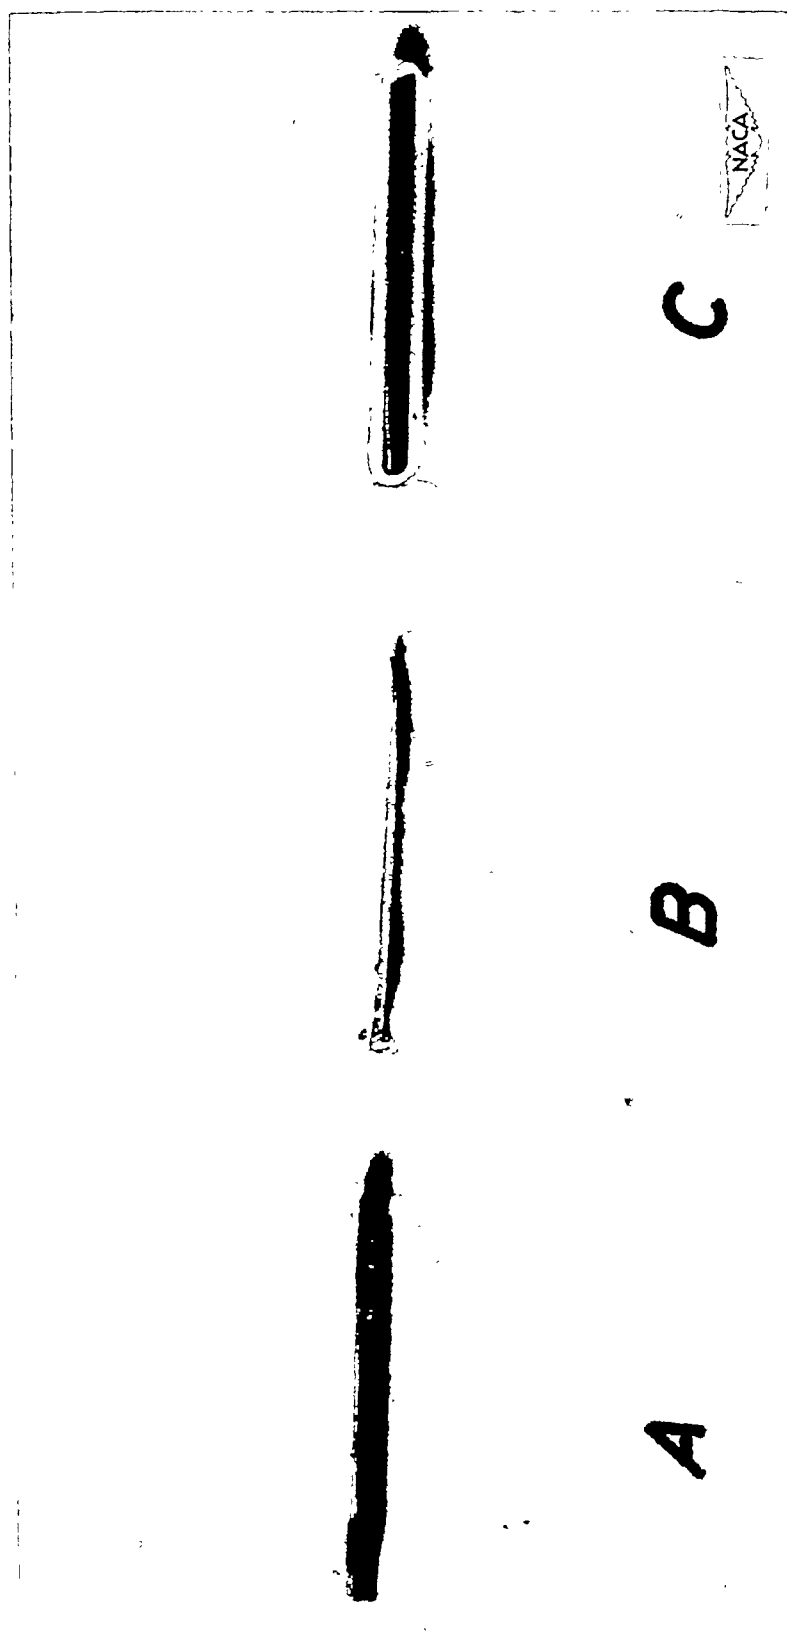
Figure 2.- Enlarged photograph (2.3X) of sections cut through coated and uncoated sheet molybdenum. Specimen A is the original uncoated molybdenum 0.040 inch thick. Specimen B is similar to A except that it has been heated for 1/2 hour in air at 1650° F, losing approximately half its thickness. Specimen C which has had a ceramic coating applied at a thickness of 0.028 inch has undergone 70 hours of heating in air at 1650° F with no evidence of oxidation of the metal.

Specimen A, in figure 2, illustrates the uncoated molybdenum metal while specimen B shows a section of the same metal after 30 minutes of heating at 1650° F. It will be noted that specimen B, with no coating, has been reduced to one-half of its original thickness in only 30 minutes of heating while specimen C has maintained its full thickness throughout 70 hours of heating.

Although the test results illustrated by figure 2 demonstrate definite potentialities, the extended use of coatings for protection of molybdenum at operating temperatures in the range from 1300° to 1800° F does not appear probable, as long as suitable heat-resisting alloys for these temperatures are available. There is no assurance, however, that the high-cobalt alloys will be available in sufficient quantity to meet a greatly expanded demand. If this demand should develop, these alloys could probably be supplemented by high-molybdenum alloys for use at temperatures beyond those now feasible provided suitable protection against oxidation could be effected by means of a ceramic coating.

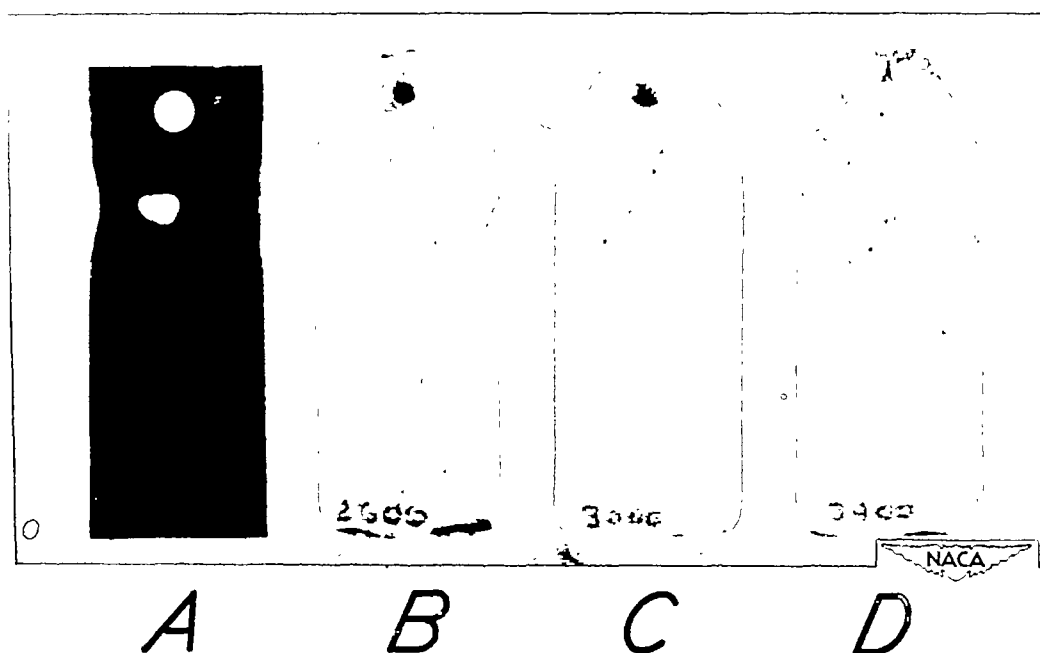
Figure 4.- Molybdenum specimens after exposure to flame testing. Specimens B, C, and D have been coated with M-13-33 at a total thickness of approximately 0.033 inch and have been treated for 30 minutes at surface temperatures of 2600°, 3000°, and 3400° F, respectively. Specimen A is uncoated and the hole was burned through it when it was treated for 3 minutes under the same flame adjustment as for D.

Figure 4 shows three M-13-33 coated specimens that had been heated 1/2 hour, instead of 5 minutes, at 2600°, 3000°, and 3400° F. No thickness loss was indicated for any of these three coated specimens. A specimen of uncoated molybdenum sheet was subjected to the same flame condition that had given a surface temperature of 3400° F on the coated specimen. During the heating, the uncoated specimen reached a temperature of 2800° F. Intense fuming of the oxide was noted under these conditions. Within 3 minutes a hole had been burned through the unprotected metal specimen, which is shown with the coated specimens in figure 4. Figure 5 shows a heavy deposit of the crystalline molybdenum oxide formed in a symmetrical pattern by sublimation on the cooler portions of the refractory supports during the heating operation.

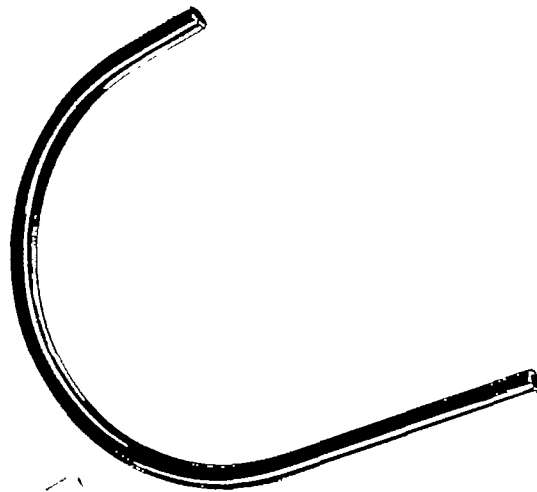
Figure 6.- Uncoated and coated molybdenum pitot tubes approximately 10 inches long, of a type used for recording pressures in the 3000° F blast of a ram-jet engine. The white tube has been given a ceramic coating except for a distance of 1 inch at the end not heated in service.

In figure 6 are shown two molybdenum pitot tubes approximately 10 inches long, the white one of which has been given a ceramic coating, except for a distance of 1 inch at the end not heated in service. These tubes had $\frac{1}{4}$ -inch outside diameters and $\frac{1}{16}$ -inch walls. The coating was applied to both inside and outside surfaces by submersion of the specimen into the slip, followed, after drying, by a spray-coat reinforcement at the end exposed to high temperature. After the spray coat was dried, the specimen was fired at 2150° F on a Nichrome supporting rack in the oxygen-free atmosphere of the previously mentioned Hayes furnace.

Twenty-four of the tubes as shown in figure 6 were given exterior and interior coatings of the M-3-8 type and one with coating M-13-35. These were used in ram jets attached to the wings of aircraft. One tube with each type of coating was returned after undergoing this service and examined with a binocular microscope. Neither tube had failed in service, except for breaking near the end that was welded to a steel tube and which operated at a relatively low temperature.

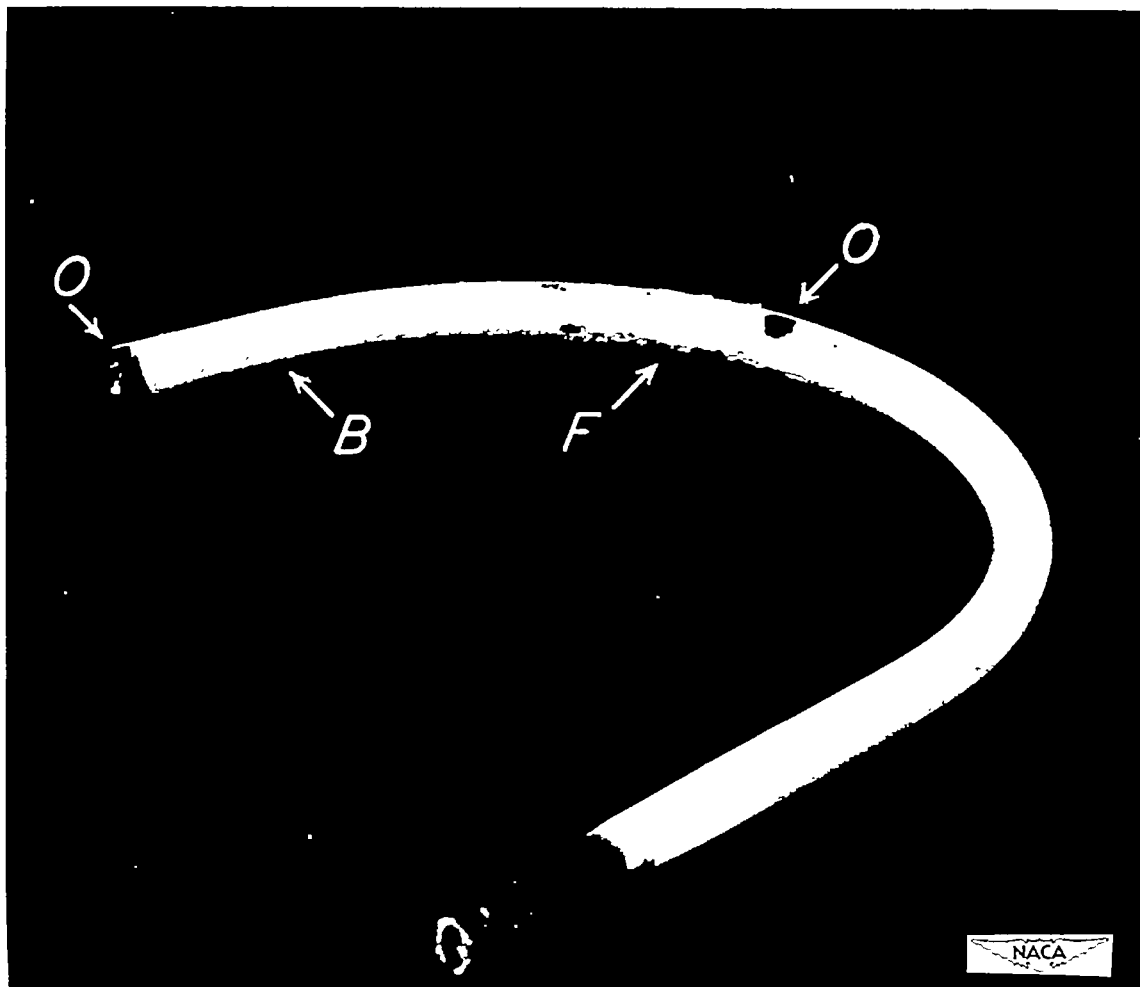
Figure 7.- Coated pitot tube of the type shown in figure 6 after 45 minutes of service operation in blast of ram jet at computed gas temperature of 3000° F. Although deterioration of the coating has occurred, the tubes have performed satisfactorily under conditions which would have caused serious oxidation of uncoated parts.

The M-13-35 tube (coating thickness, 0.008 in.) had undergone 45 minutes of service without any considerable oxidation of the metal except at two spots. One of these spots, shown as O at the upper end of the tube in figure 7, was originally not so well protected as on the M-3-8 tube inasmuch as it had not been reinforced with extra coating at the tip. As a result, the protection at this point terminated during the test and considerable oxidation occurred. The dark area indicated as O at the central section of the tube was believed to have resulted from damage to the coating during installation. Oxidation had progressed sufficiently at this area to halve the thickness of the tube wall. No serious damage had occurred elsewhere, although several small spots appeared to have lost the coating, possibly near the end of the 45-minute test period.

The speckled appearance of the coating on the tube at B in figure 7 is caused by healed blisters in the coating. There is evidence also of flow of the coating, which is apparent at F in the photograph as ripples in the surface. This flow was believed to have occurred at the moment the blisters formed. The blisters caused added obstruction to the smooth flow of the high-velocity gases. The flow of the coating reduced this obstruction.
